Operating Experience Weekly Summary 97-25

June 13 through June 19, 1997

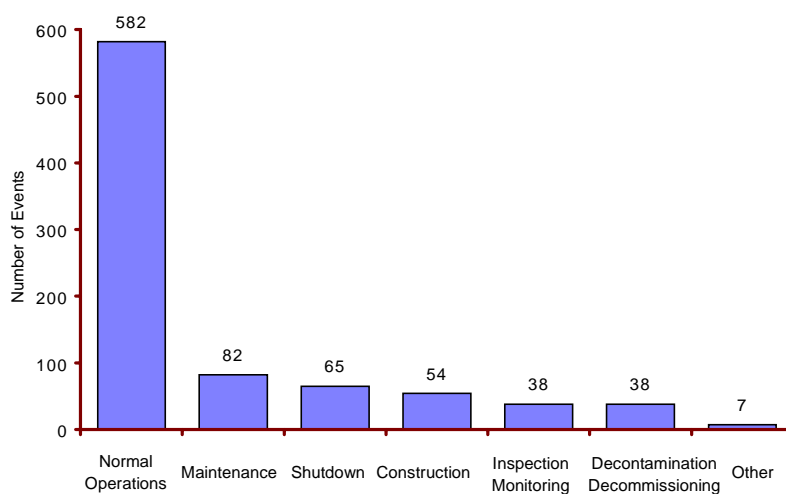
Operating Experience Analysis and Feedback (OEAF) engineers reviewed the Occurrence Reporting and Processing System (ORPS) database for personnel contamination events caused by personnel error and found 820 reports involving 866 occurrences DOE-wide. Over 67 percent of the events occurred during normal operations. Almost 59 percent of the personnel errors were coded as inattention to detail. Figure 3-1 shows the types of activities being performed when individuals were contaminated.

Figure 3-1. Activity Categories For Contamination Events Caused By Human Error¹
